# Yatesville Lake

## Foundation Report Volume I

Construction of Dam and Appurtenant Works, Phase II  
Contract Number DACW69-86-0039

September 1990

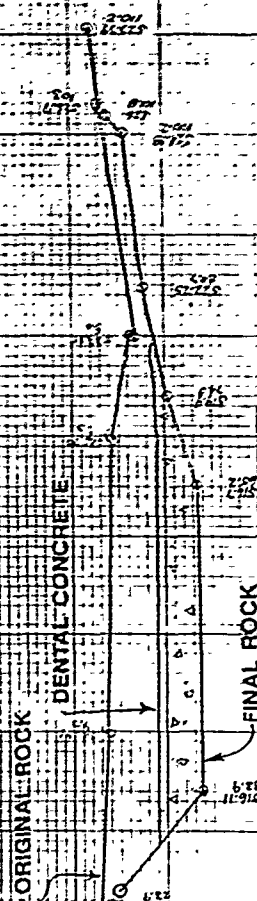
## DENTAL TREATMENT OF BROKEN ZONE

After overburden excavation was completed at the dam site, a conspicuous broken zone was discovered in the sandstone foundation at Station 5+85 from elevation 521 to 524. This broken zone required an exploratory drilling program to discover its extent, orientation, and severity. A series of 11 vertical 4-inch core holes were drilled (hole numbers EX-1 through 11), in September 1987, at various locations near the broken zone. During drilling a 6-inch-diameter roller bit was used for the first two feet to accommodate the length of the 4-inch ID core barrel. Depths of these exploratory holes varied from 11 to 22 feet with occasional core loss (0 - 60 percent loss) occurring in broken zones.
